Spot Safety Project Evaluation

Spot Safety Project # 14-97-017

**Spot Safety Project Evaluation of the Directional Crossover Installation,
At the Intersection of US 23-74 at SR 1527-Steeple Drive and SR 1449-Cope Creek Road
Near Sylva, Jackson County**

Safety Evaluation Group
Traffic Safety Systems Management Section
Traffic Engineering and Safety Systems Branch
North Carolina Department of Transportation

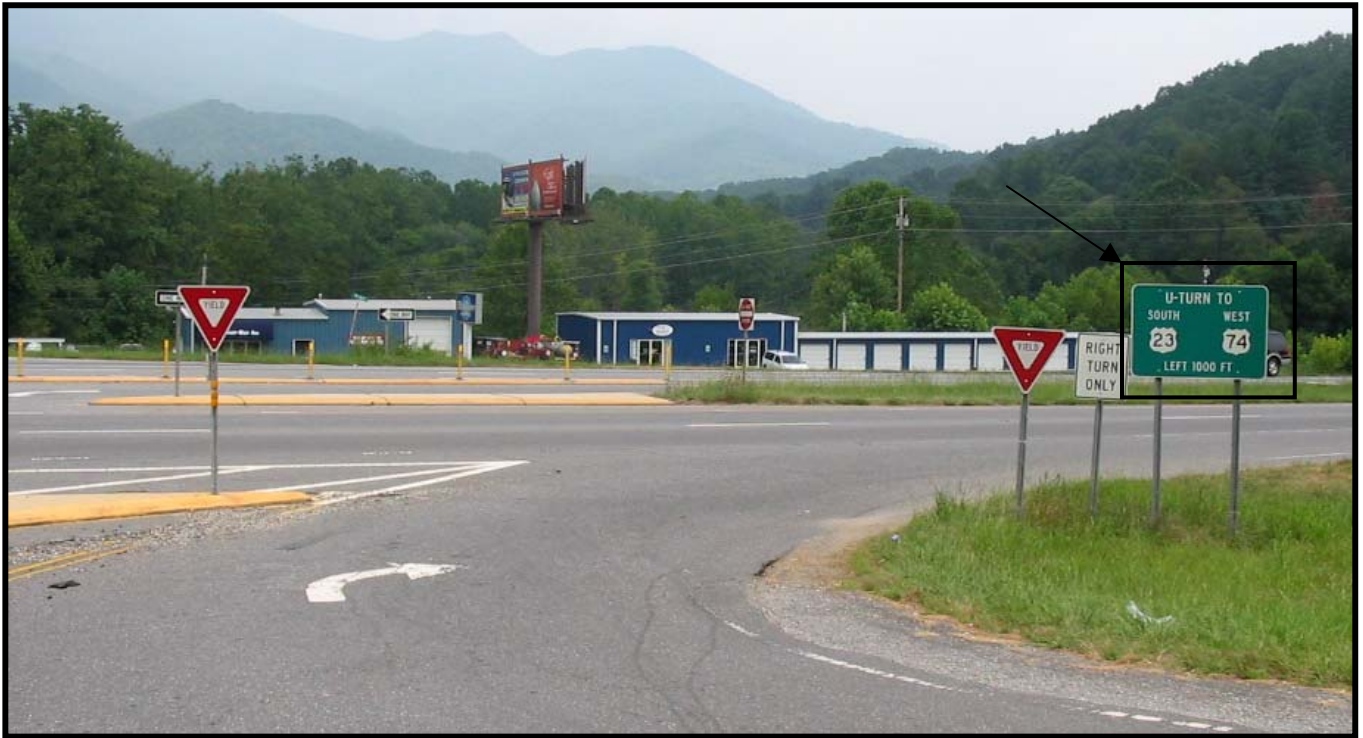
Looking north on SR 1449 at the Treatment Location
Notice the “U-Turn To South US 23/ West US 74” sign located to the right of the Yield signs.

Please see the attached *Treatment Site Location Photos*. Photos are provided of the treatment intersection and of the surrounding U-turn locations. The photos show the current signage directing motorists to the nearest U-turn locations. In addition, the photos show the "U-turn Traffic Entering" signs located on US 23-74 in advance of the treatment location.

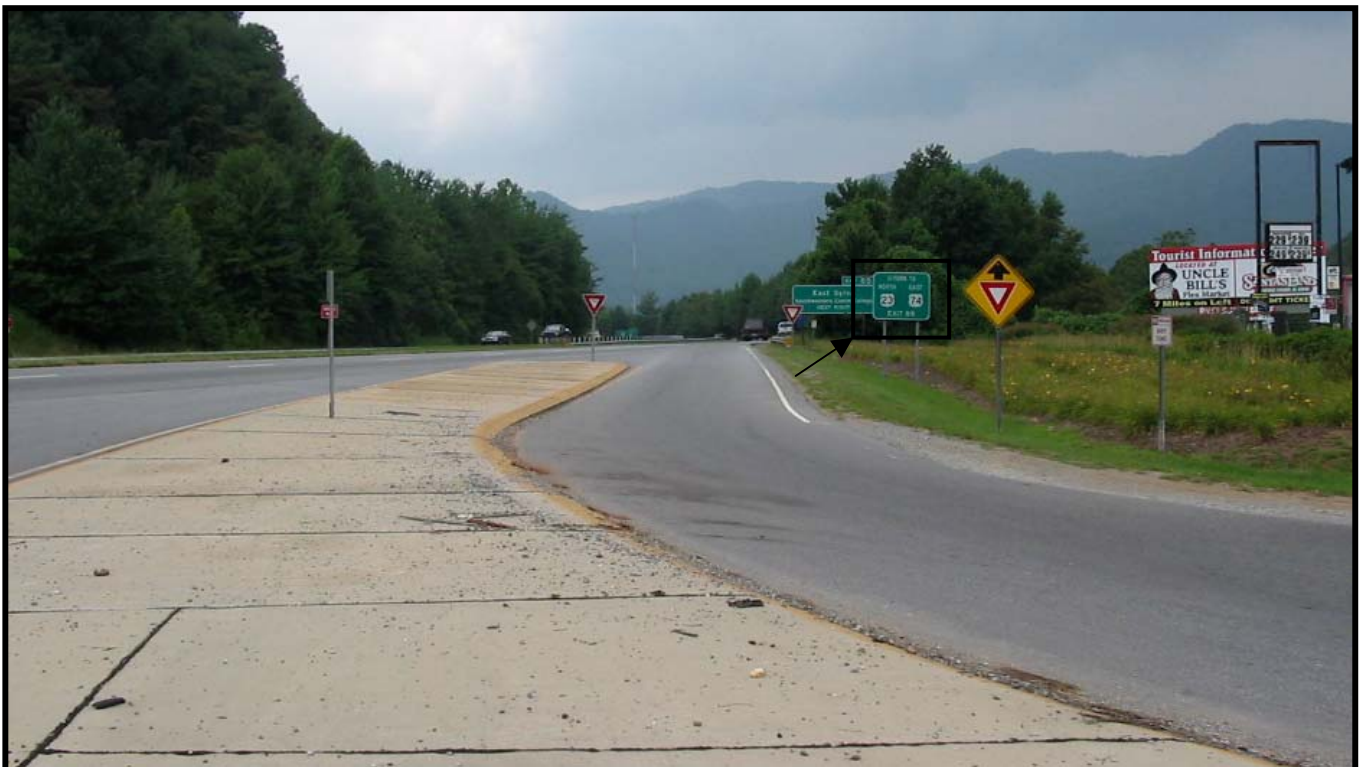
Looking west on SR 1527 at the Treatment Location
Notice the “U-Turn To North US 23/ East US 74” sign located to the right of the Yield signs.

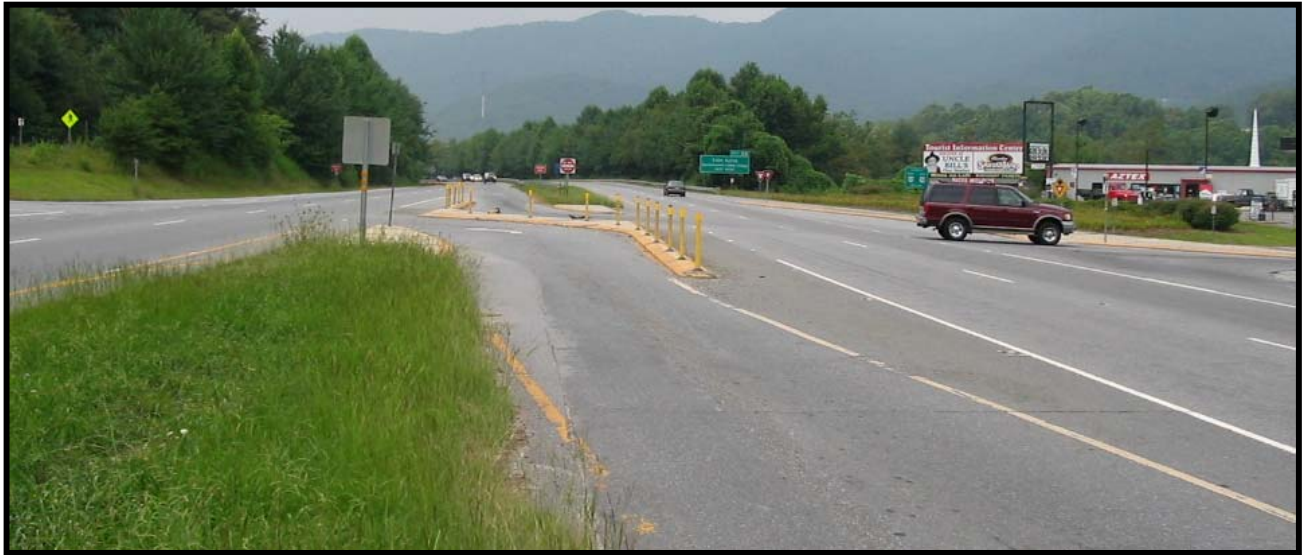
Looking west on US 23-74 at the Treatment Location

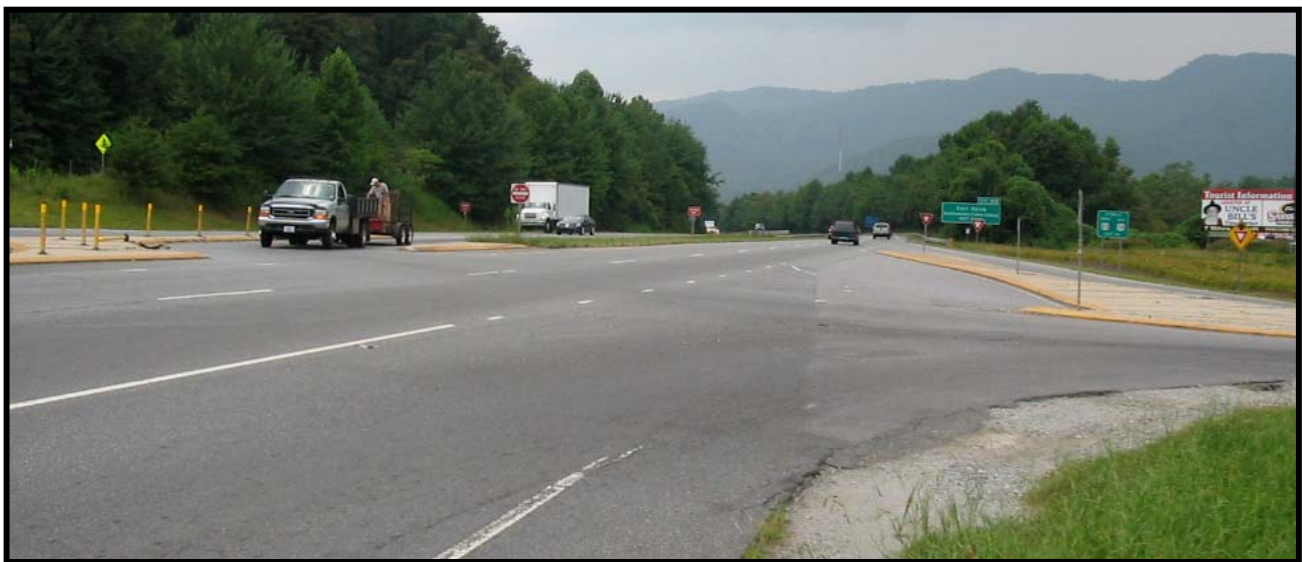
Looking west on US 23-74 at the Treatment Location
Notice the Bulb-Out for motorists making U-turn movements from the Crossover.

In the after period, three crashes occurred at the treatment location that involved eastbound US 23-74 vehicles making a U-turn and being struck by oncoming westbound US 23-74 vehicles. One of these crashes resulted in a fatality. A bulb-out is provided for the U-turning movement; however, there is no acceleration lane provided for motorists to gain speed after making the U-turn movement. US 23-74 carries a high volume of traffic, most of which appeared to be travelling at or over 55 mph during the site visit. While viewing the location, it appeared that most U-turning motorists were either getting stuck in the bulb-out or completed their movement and were almost rear-ended by oncoming vehicles. Four Left-Turn, Same Roadway crashes also occurred at the treatment location in the after period. All of these involved eastbound US 23-74 motorists turning in front of westbound US 23-74 motorists. "U-turn Traffic Entering" signs are currently placed in advance of the treatment intersection on both US 23-74 approaches. However, westbound travelling motorists may require more notification that traffic is entering the treatment intersection ahead.

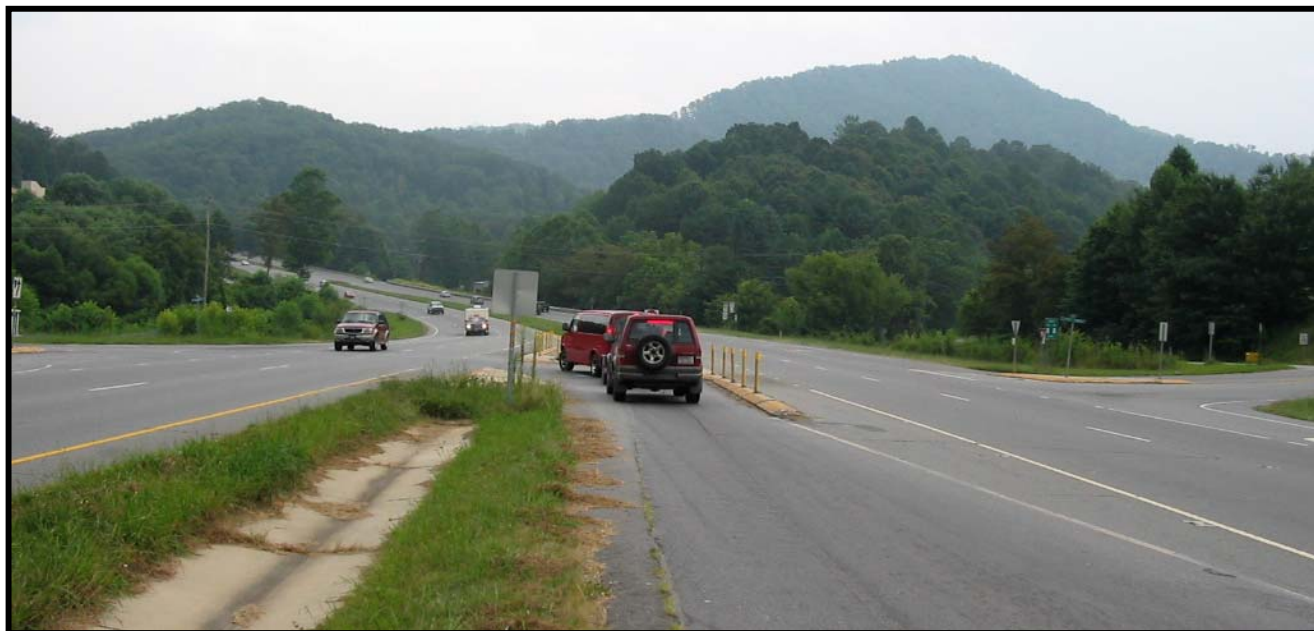
Looking east on US 23-74 at the Treatment Location

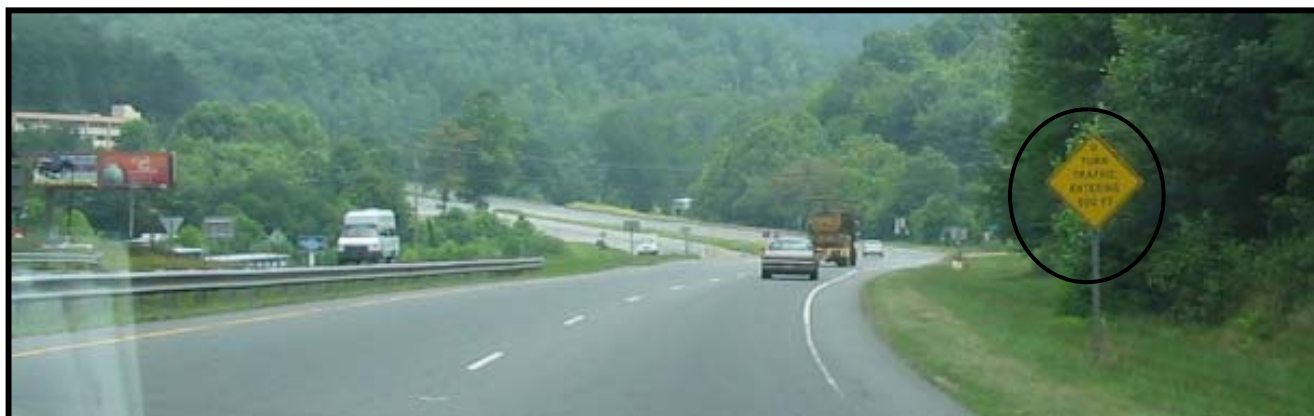
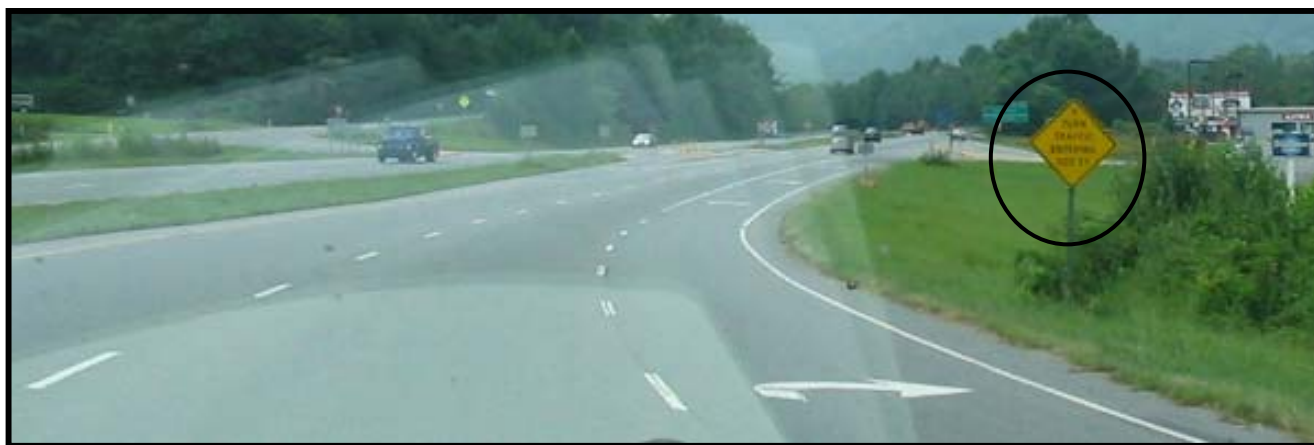
Both photos above taken while driving towards the Treatment Intersection.
Notice the "U Turn Traffic Entering" Signs Posted on both US 23-74 approaches.

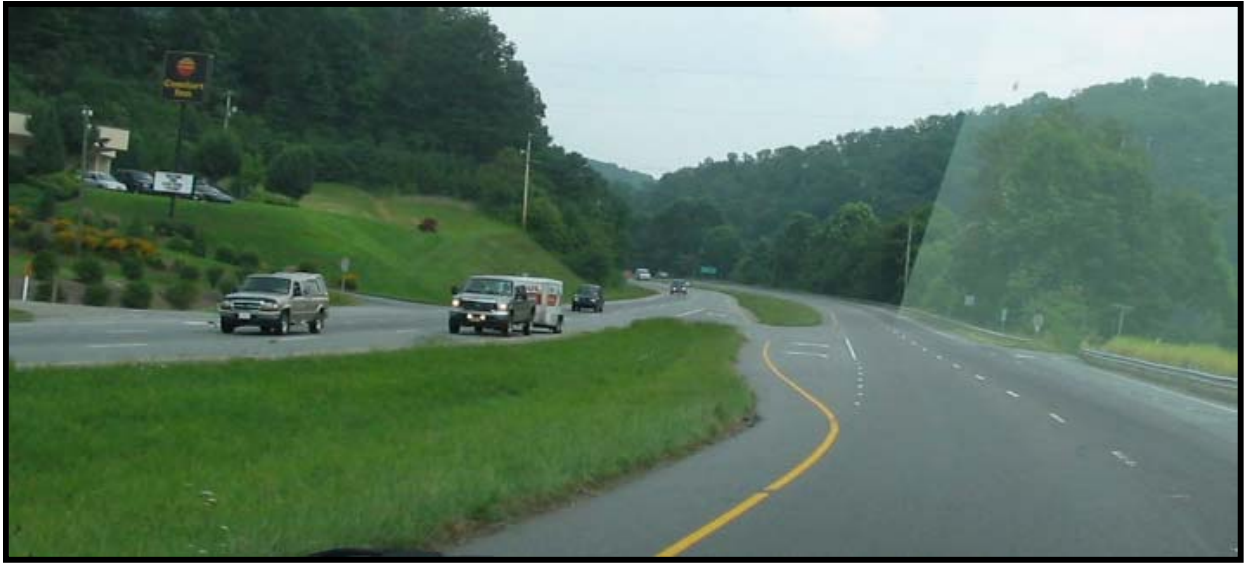
Looking east towards the intersection of US 23-74 and SR 1788-Hidden Valley Road

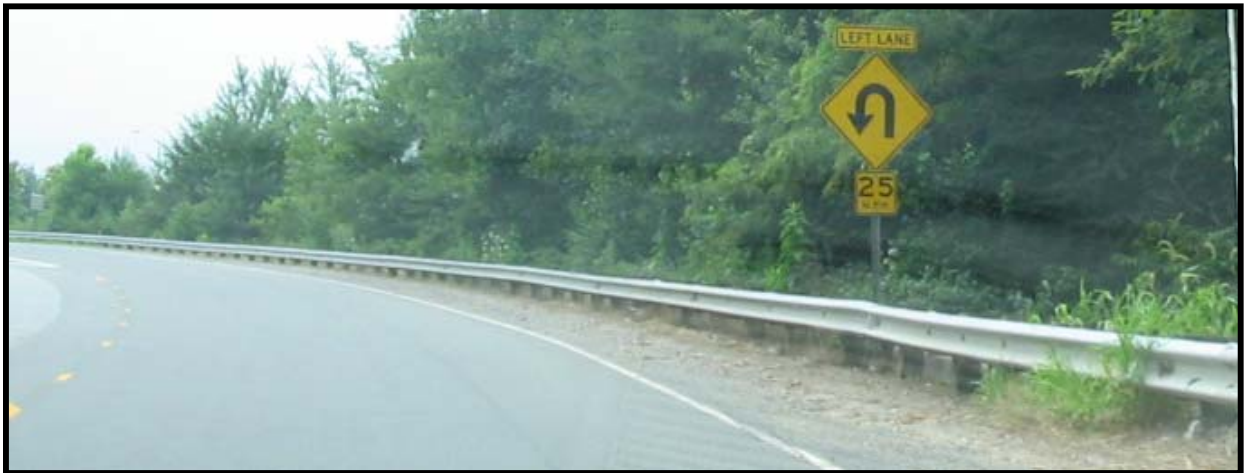
Photo above taken on the Exit 85 ramp, just prior to the U-turn. Notice the Left Lane U-turn sign.

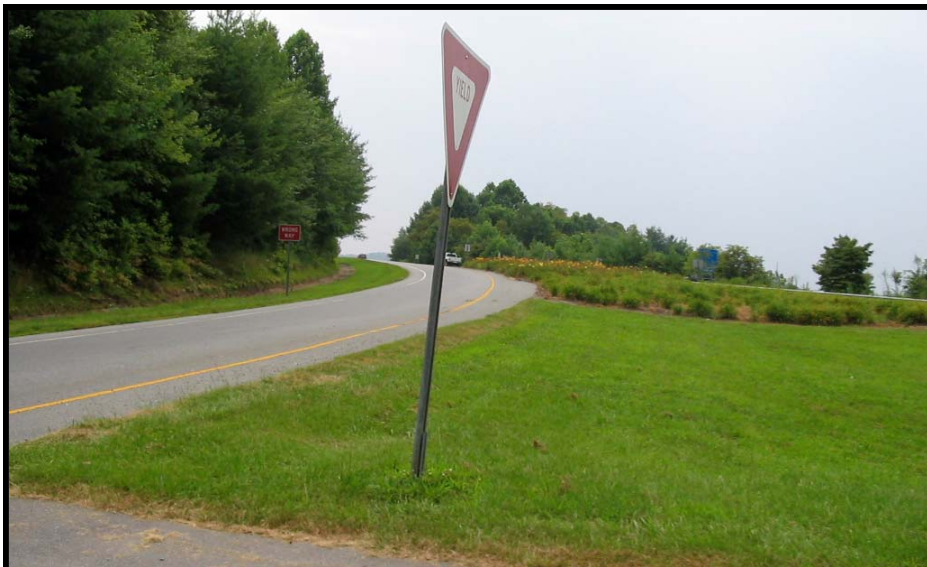
Photo at left is of the U-turn. Traffic exits the ramp and is allowed to U-turn back onto the eastbound US 23-74 On-Ramp.
